Lessons from the Past: Learnings for the Future from the Canacona Disaster

In the direction to ascertain the "cause and effect" of the event and suggest plausible measures to combat and mitigate a similar disaster in the future, a meticulous scientific investigation has been attempted through a multi-prone approach coupled with an exhaustive reconnaissance survey. Survey of India topographical maps in conjunction with satellite images integrated in a GIS environment, along with GPS have been used for the said investigations. The comprehensive investigation reveals that the catastrophe at Canacona was due to a synergy of climatic changes, coupled with meteorological, geological [lithology and structure of outcrops], geomorphologic, hydrological and human invasive factors.

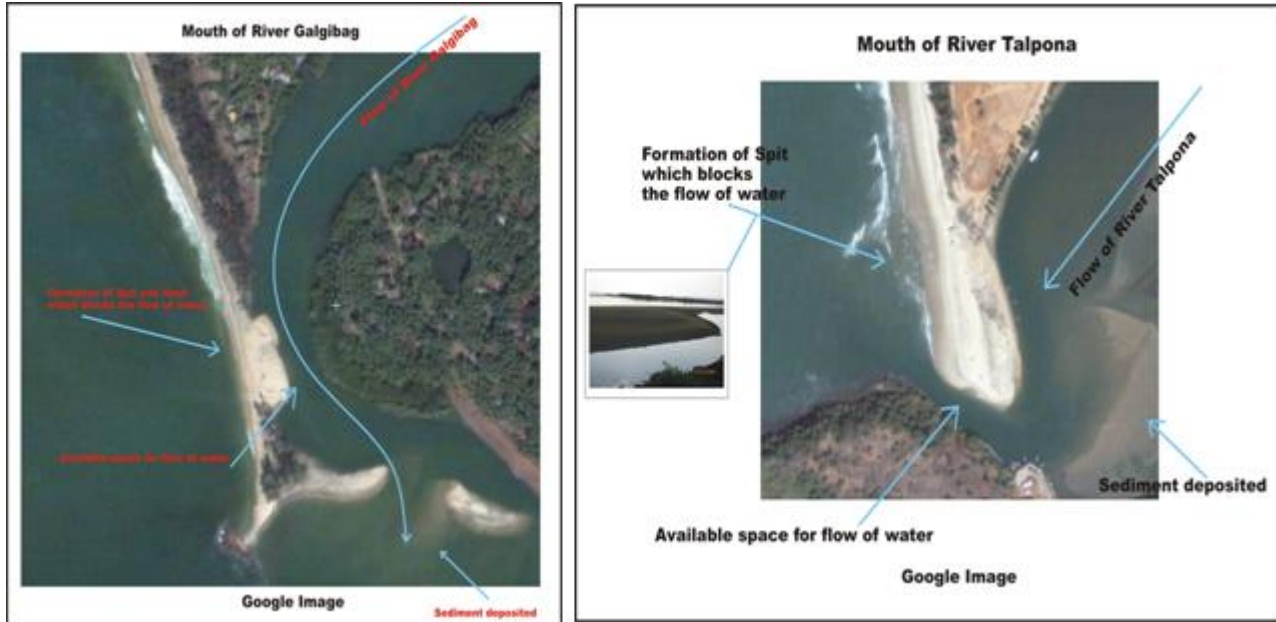
Figure 2

It is also interesting to note that at the mouth of River Talpona there is a development of Spit and near the mouth of River Galgibag there is a presence of Hook. Both these coastal features become hurdle in the smooth flow of water (Figure 2).

and hook formed at the mouth of the River Talpona and Galgibag, respectively, were ecologically dressed, to increase their water in and out flow, the vulnerability would have also been reduced.

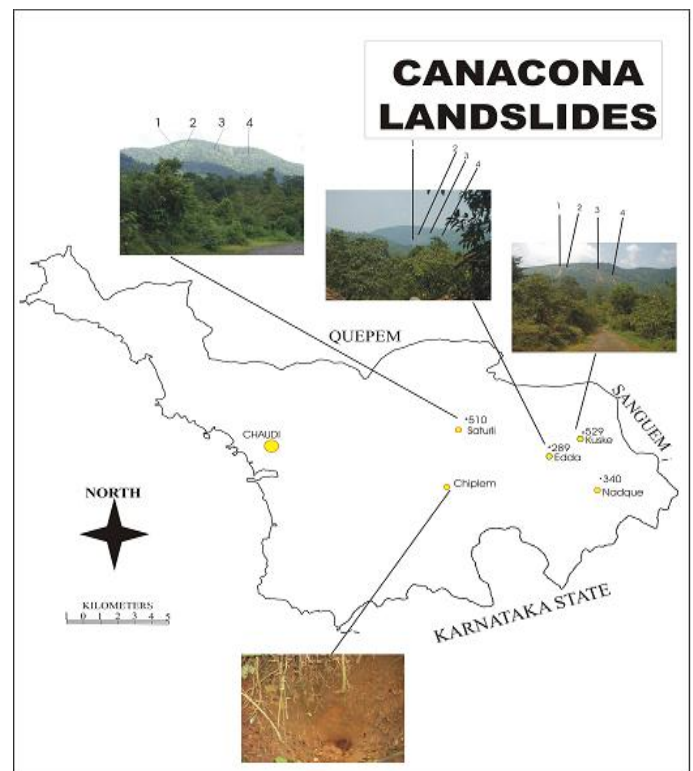
Figure 3

Landslides pose a great hazard to life and property, in the past, landslides did occur in Canacona taluka, whenever rainfall was heavy to heavy. In 2002; landslides did also occur in Kuske and Yedda and also in 2007 at Char Rasta. Occasionally small mudfall/slides also occur during the monsoon in the region and are prominent at Karmal Ghat. However, the unprecedented rainfall of 2nd October 2009, resulted into large number of landslides/mudfalls/rockfalls of varying dimensions and degree at Saturlim, (510m) Yedda (289m), and Kuske (521m). The landslides between Gaondongrem to Cotigao were numerous. In addition to

landslides, several mudfalls were also observed in Karmalghat, Char Rasta, Gaondongrem, Tudal, and Cotigao (Figure 3).

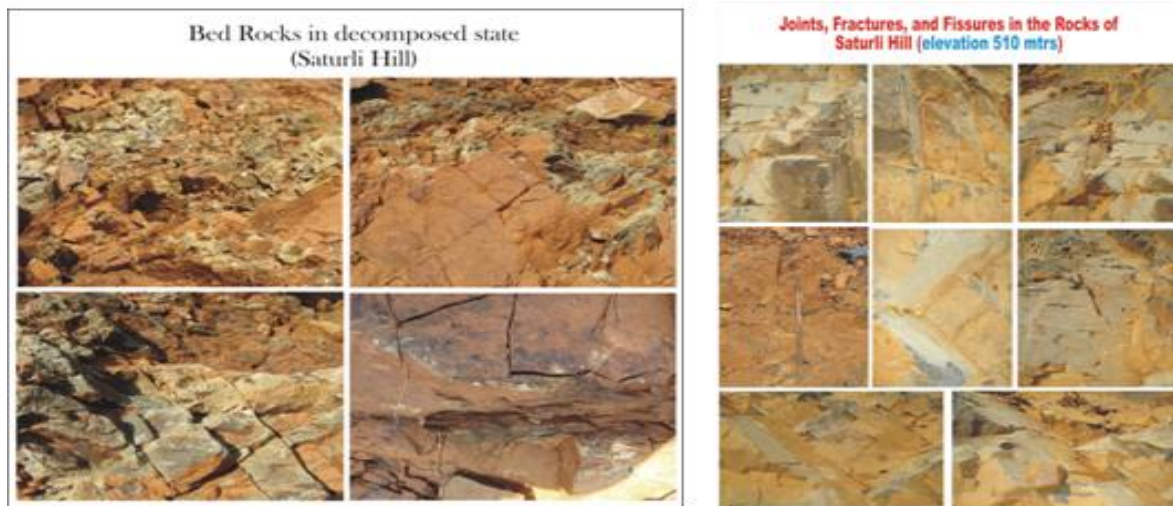
Figure 5

The bed rocks of Saturli and Yedda Hill are in a decomposed state with multi joints, fissures, and fractures. Such conditions give rise to landslides (Figure 5).

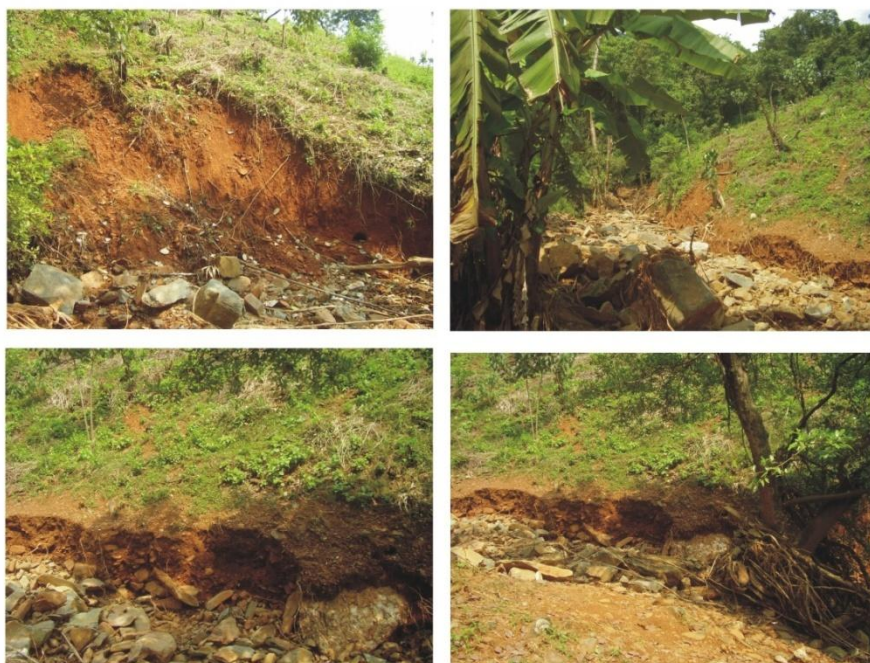
Figure 6

Human interference in this region includes kumeri cultivation, grazing, hill cutting, change in landuse from forest to agriculture and deforestation. Such human actions increase the risk of disasters. Landslide occurred at Kuske indicates the same (Figure 6).

Kumeri Cultivation and Landslide at Kuske

Hill and Slope Management: Encroachment in the hill areas for undertaking kumeri plantation and hill cutting should be regulated and strictly monitored through effective enforcement. However, if unavoidable and the hill cutting is in

public interest it may be undertaken, only under strict adherence towards maintaining appropriate and technical sound hill slope gradient and also precautionary grouting, to avoid mudfall, rockfalls and landslides. Kumeri plantation along the slopes and toe regions should be controlled, within existing usage area only. Immediate reforestation on hill slopes must be carried on the war footing, with indigenous economically and ecologically species, taking advantage of the current soil moisture content. Social forestry programs should be initiated at Saturli, Gaondongrem, and Kuske. Likewise, stability of the slope can be boosted by consolidating the toe of the hill gradient. Furthermore, and in order to stop further landslides in the region, terracing on the hill slopes is recommended like the one carried out at Char Rasta Landslide by Konkan Railway.
