# Breaching of Earthen Dams due to Washout of Fuse Plug

## ABSTRACT

## 3. Experimental Programme

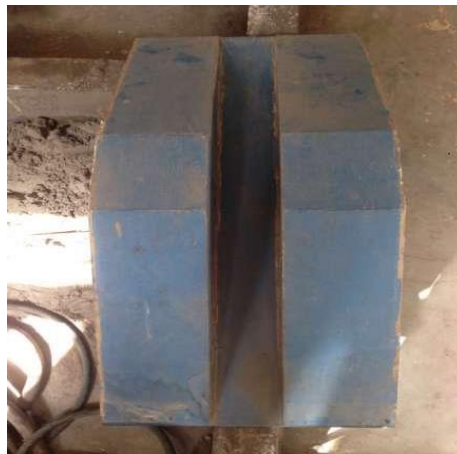
The fuse plug was fabricated using the wooden material and polished before placing in the flume to avoid seepage (Figure 3). The dimensions of fuse plug model are tabulated in table 1.

Figure 3: Fuse plug model

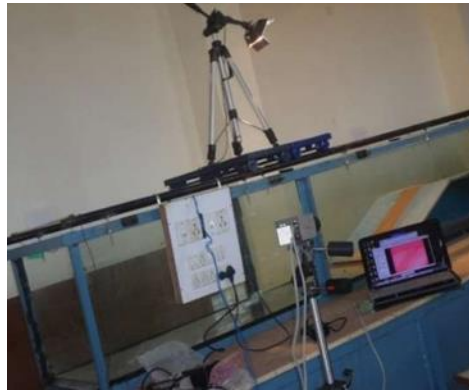
For studying the different tests, a fuse plug model, soil of different proportions, a compaction roller along with essential standard laboratory devices were used. A high-speed digital video camera (Figure 4) and digital cameras were also used

Figure 4: Experimental Set up

dam model, clay layer was laid to reduce seepage and the water was filled on upstream side upto the specified level by controlling the inflow with head regulator attached to inflow pipe. Pointer guage was used to for measuring readings at temporal variation. Water depth was taken upto a height of 22 cm on the upstream side of the model. Water was collected and retained for the one day for considering homogenous saturation of embankment.

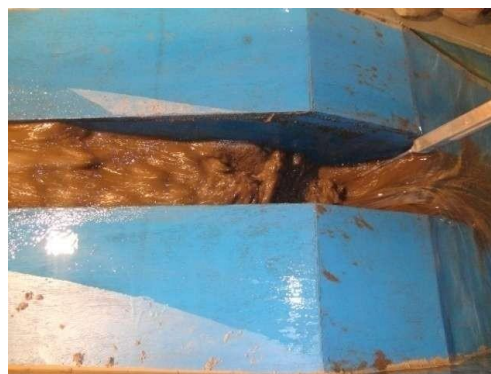
Figure 6 (a): Widening of breach

For cohesive and non-cohesive soil, test 1 and 7 were considered for describing water surface profile through channel. For cohesive soil as shown in figure 6 (a), the headcut widens and rate of erosion largely affected by cohesion of soil and the slope of headcut steepens. So, the soil material influences the rate of erosion and the influence may vary several orders of magnitude. For non-cohesive soil as shown in figure 6(b), the slope of water surface remains almost constant with the steep erosion of downstream face. From the literature, the slope of eroding headcut is equal to static friction angle. Figure 7 (a) and 7 (b) describes the temporal variation of embankment breach profile.

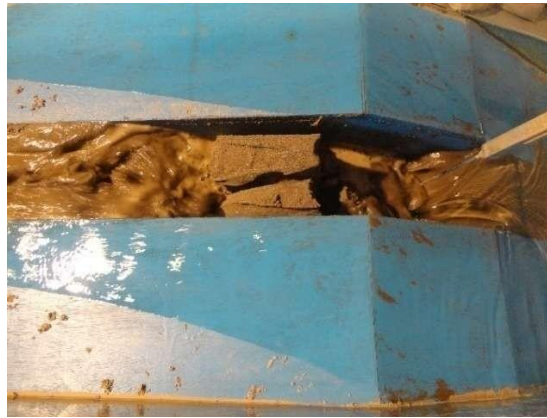
Figure 6 (b): Caveing in of sediment
